NAVAL FIGHTERS NUMBER FORTY

Grumman

F11F TIGER

BY CORWIN "CORKY" MEYER
SQUADRON HISTORIES BY STEVE GINTER

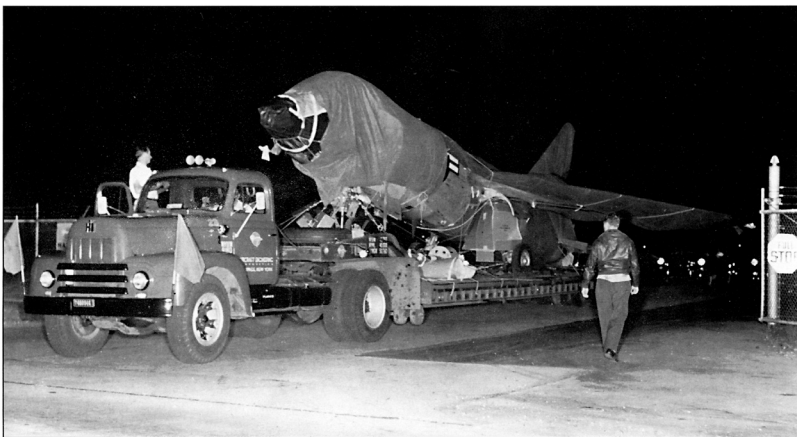
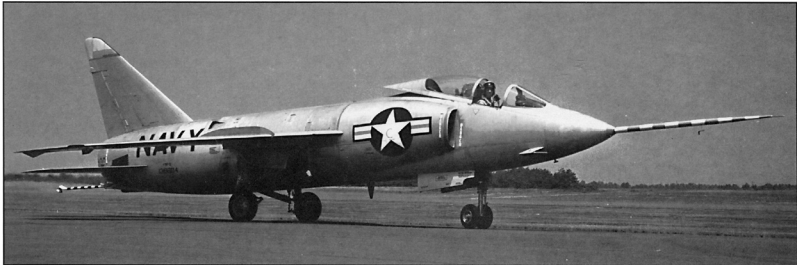
Above, Corky Meyer taxiing back from a high speed taxi/lift-off on 28 July 1954 prior to the first flight.. The wing fences extended around the leading edge of the wing. These were shortened after the first flight when it was found that they were no better than the ones that stopped 8 inches behind the wing leading edge. As a safety measure, the hook was in the extended raised position in case it was needed to arrest the Tiger in case of an emergency. Once extended, the hook could not be retracted from the cockpit, it could only be raised or lowered. (Grumman via Corky Meyer)

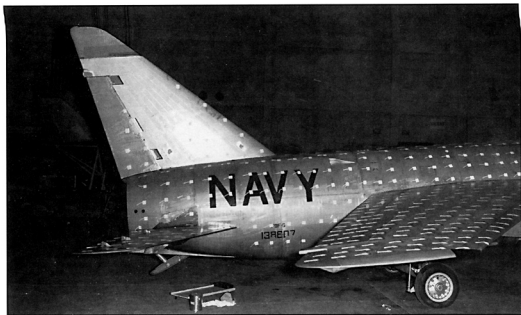
Above, after the loss of the number one Tiger with its very sophisticated pressure measuring system for the entire fuselage of the aircraft, we had to revert to the old fashioned way of tufting the airplane with short yarn pieces taped to the skin of the airplane. A chase pilot could see the air flow at all flight conditions. The main reason for tufting the wing was to determine the flow condition in the take off and landing condition to show the increased turbulence of the air flow as the airspeed is decreased to the wing stall. This was done on the number four Tiger. (Grumman via C. Meyer)

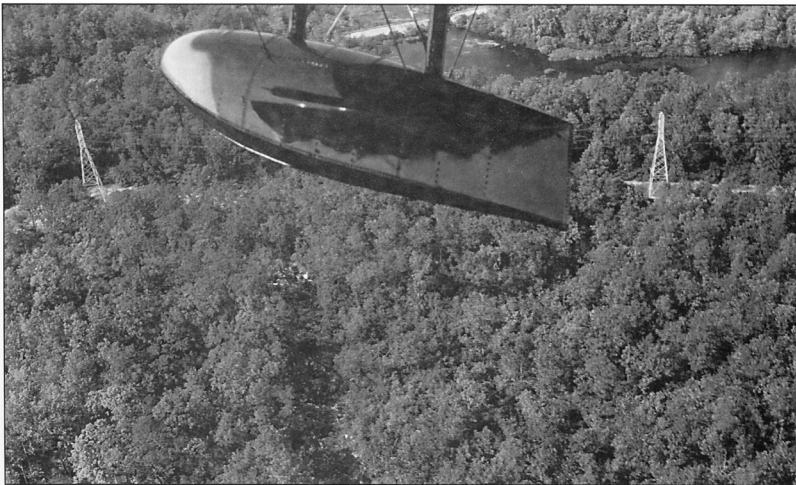
At left, bullet as found in the engine after the crash. Below, the bullet after its removal from the engine. (MFR via Meyer)

Above, the final resting place for Tom Attridge's Tiger, which was only about 1/4 of a mile from the end of the runway at Calverton. You can see the path of trees that he cut down. It is easy to see that the helo pilot might have had a job finding Tom in this jungle. (MFR via Meyer)

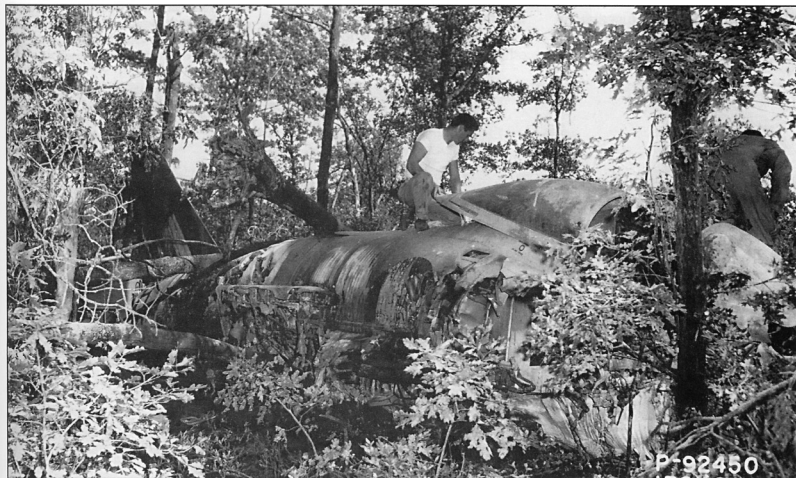
Below, the trees were over 12 inches in diameter and they took off the wing and tail from both sides of the fuselage. It was a wonder that the airplane stayed upright until it came to a stop. (MFR via Meyer)

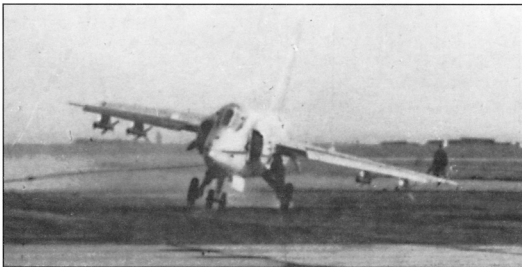
At right, John Norris makes a 20 foot off-center arrestment of BuNo 138614 at Patuxent River, Md., in January 1957. This was the maximum off-center arrested landing requirement. After the tail hook caught the wire it yanked the airplane to the right 30° from its original landing path, almost causing the right wing to hit the ground. To compound structural requirements further this landing was also a maximum limit sink speed of 17 feet per second as it caught the wire. The USAF had no off-center requirement and required only a maximum sink speed of 10 feet per second. (via John Norris)

In preparations for carrier testing, the landplane demonstration consisted of 84 arrested landings up to a vertical sink speed of 17.4 feet per second. An 8 foot per second landing is rough. Above 10 feet per second the airplane is inspected between each landing. A 17.4 feet per second landing is a controlled crash.

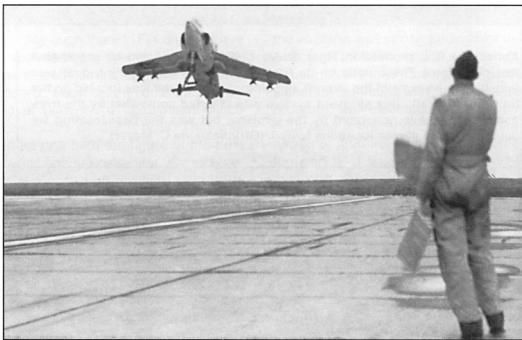
Above, minimum landing speed field carrier landing trials at NATC Patuxent. The test pilot has just been given the cut instruction as seen by the landing signal officer moving his right arm flag to his left side. (Grumman via C. Meyer)
